**PHOTOGRAPHIC
EVALUATION REPORT
MISSION 1028-1
24-29 DECEMBER 1965
MISSION 1028-2
29 DECEMBER 1965 -
2 JANUARY 1966**

**SEPTEMBER 1966
COPY
185 PAGES**

NATIONAL PHOTOGRAPHIC INTERPRETATION CENTER

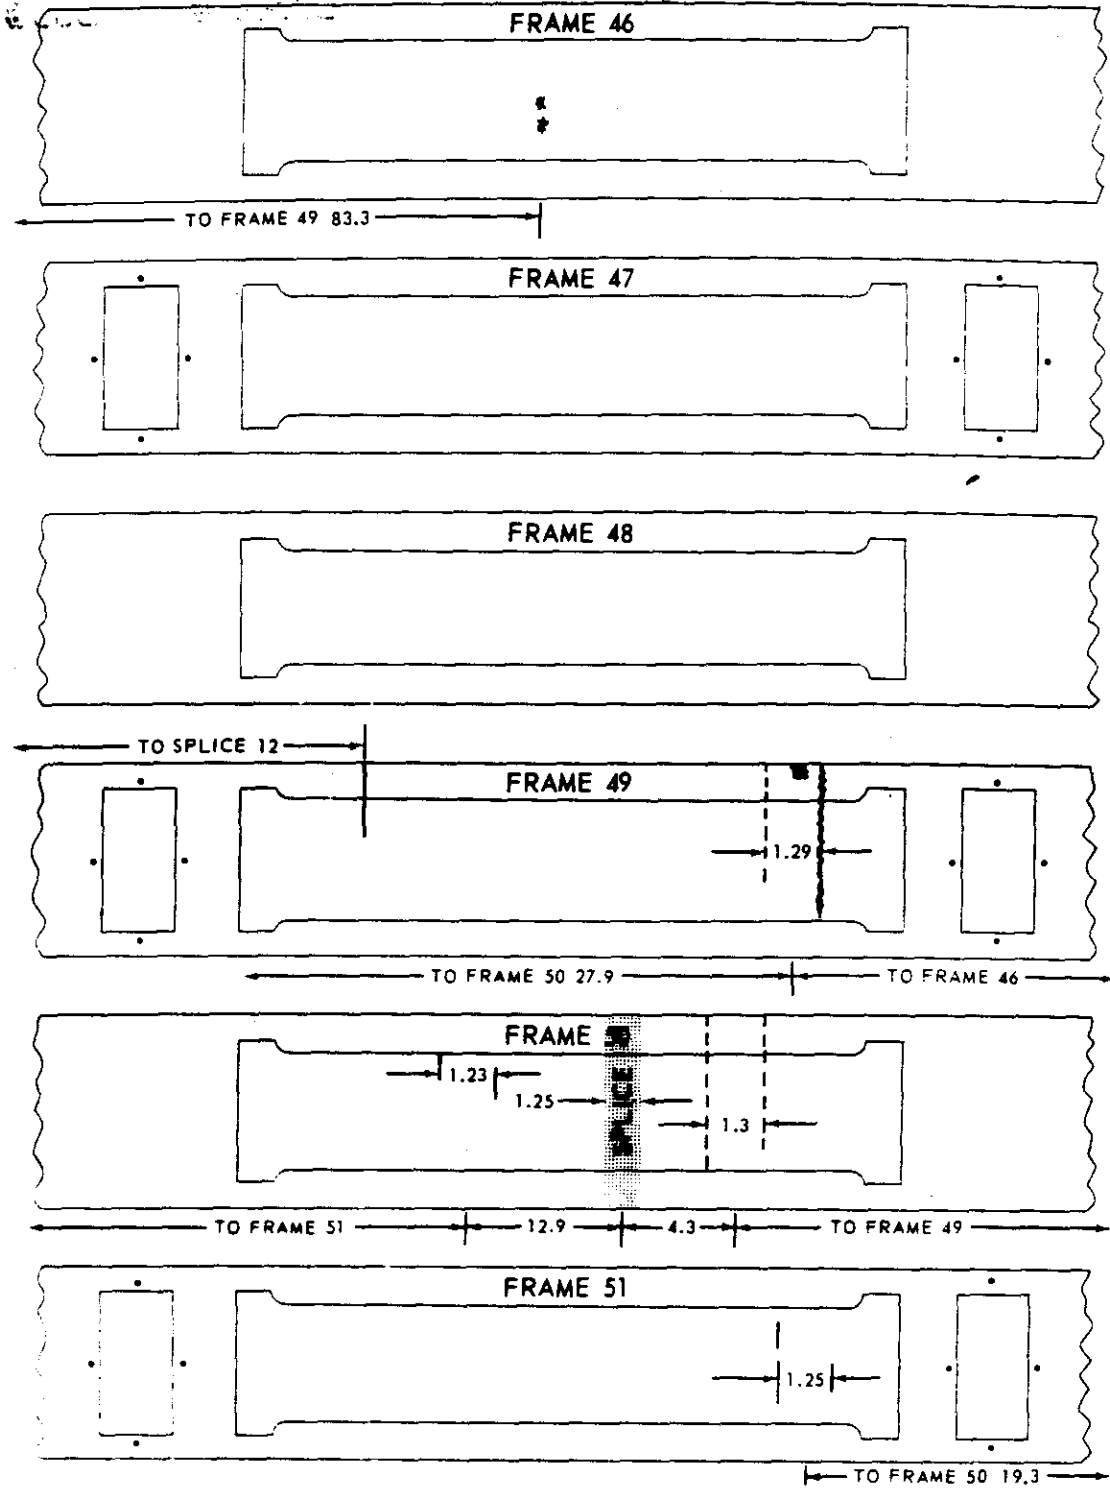
FWD 130D

b. An area of out-of-focus imagery was detected at the supply end, camera number edge of the format in passes 130D and 131D. The out-of-focus condition is first noticeable in frame 12 of pass 130D but the degradation is slight. The condition becomes progressively more severe and reaches maximum degradation by frame 15. Thereafter, the degree of severity remains fairly consistent, being slightly less in some instances. The out-of-focus area thus continues through frame 25 of pass 131D. It is not present in frames 86 through 111 of pass 131D, but is detectable in frames 112 through 127. The degradation in frame 127 is slight and there is no out-of-focus area present in any succeeding frame. The maximum area affected by this condition

Pitch measurements (measurements between the film edge and format edge at each end of the frame) show that the format has a greater bias in those frames which display the focus degradation. The location of a manufacturer's splice in frame 50 of pass 130D suggests the possibility that either a change in film tension due to the adhesion of the splice to a successive film wrap or a bias in the joined material caused a slight mistracking of the film.

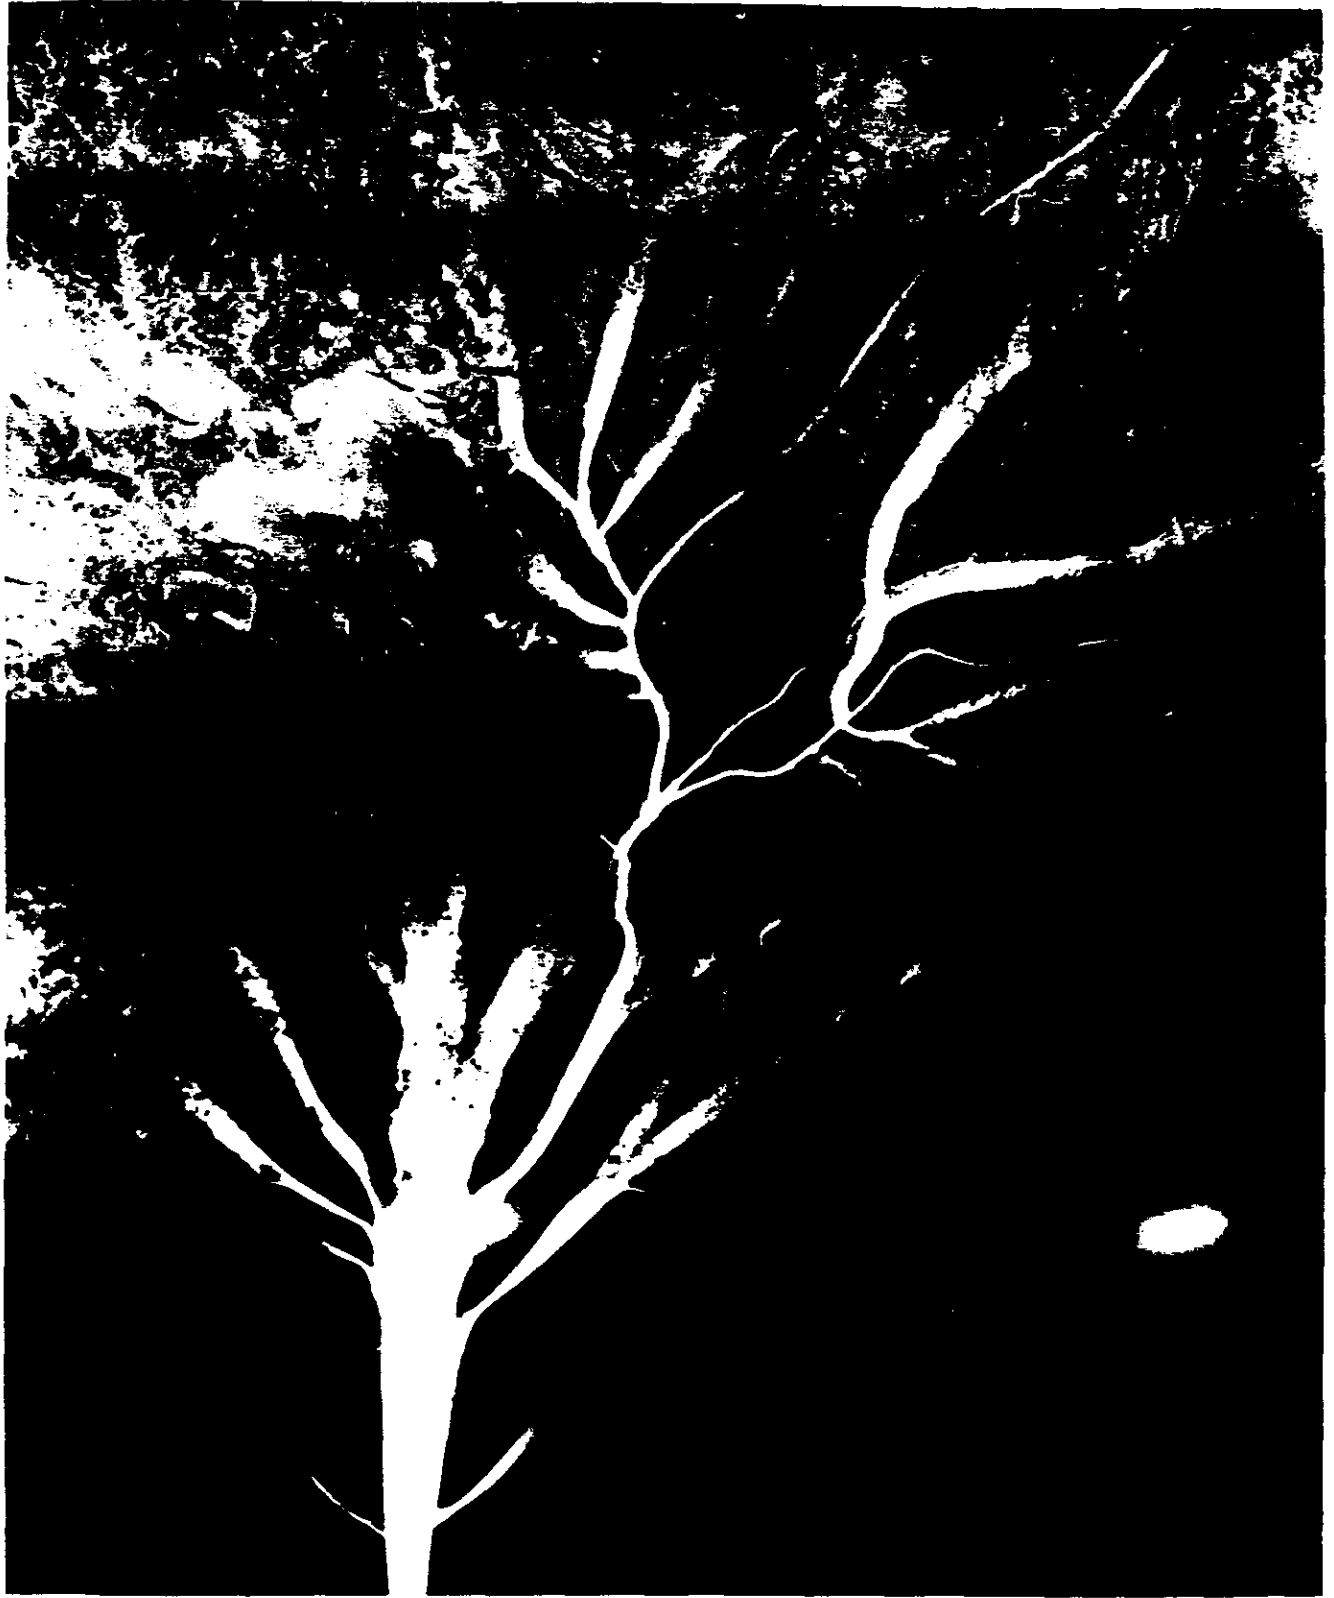
FIGURE 11. IMAGE OF FOREIGN MATTER

The first few passes of the aft photography contain streaks of minus density. These minus density streaks have been noted on previous missions and have been attributed to obstructions in the optical path caused by particles of foreign matter in the system. It is seldom that the streak-causing particles are imaged as a stationary object rather than as a streak. The minus density streak caused by this particle, although not visible in the illustration, is present in the scan direction trailing the stationary image.

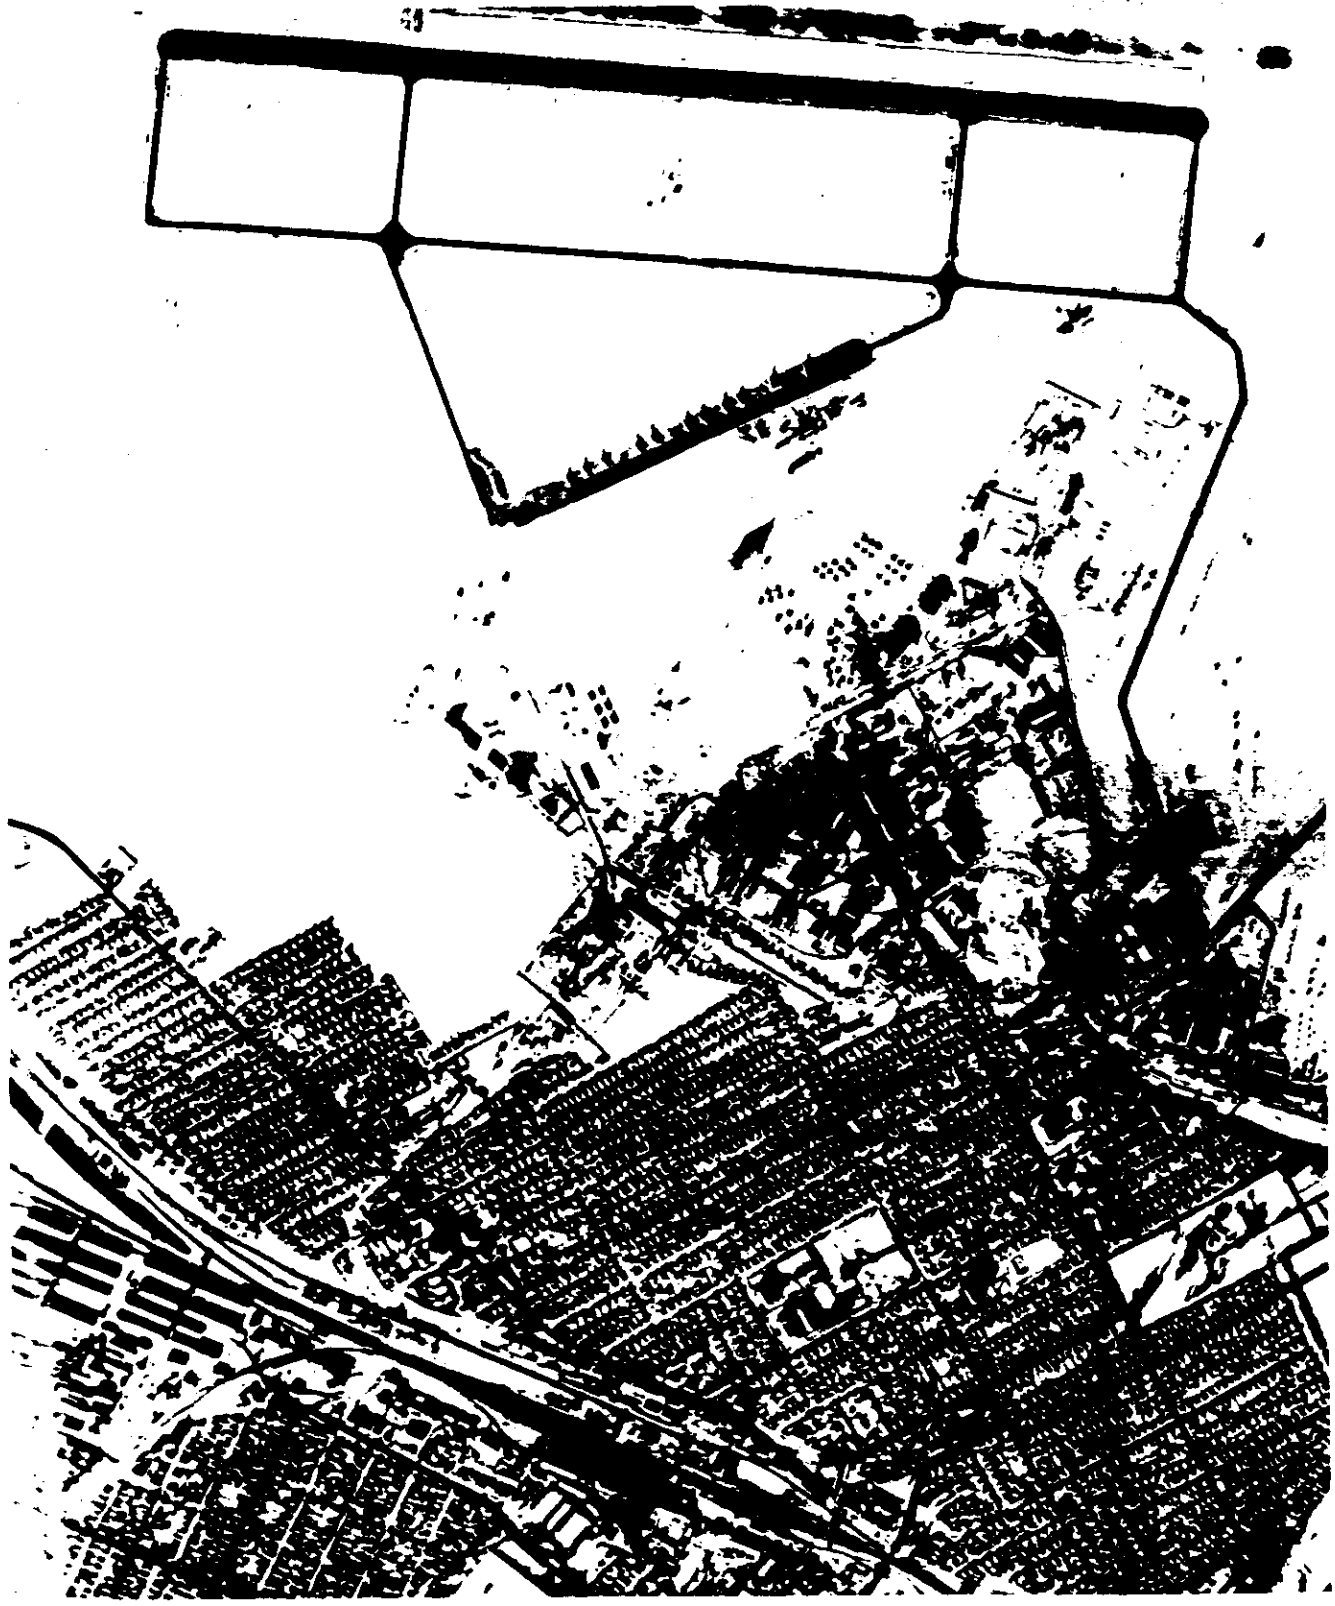
FIGURE 15. EXAMPLE OF FORWARD, SNOW-FREE PHOTOGRAPHY

The slightly better quality of the aft-looking photography can be observed in the following illustrations. The additional detail present in snow-free photography is readily seen when these photographs are compared with those of the preceding illustration.
